FINAL
REPORT OF
PRODUCT IMPROVEMENT TEST OF U-8F
(ECP-BEA-L23-138)
USATECOM PROJECT NO. 4-4-1004-01

22 DEC 1964

U S ARMY
AVIATION TEST BOARD
FORT RUCKER, ALABAMA

PRODUCT IMPROVEMENT TEST OF THE U-8F

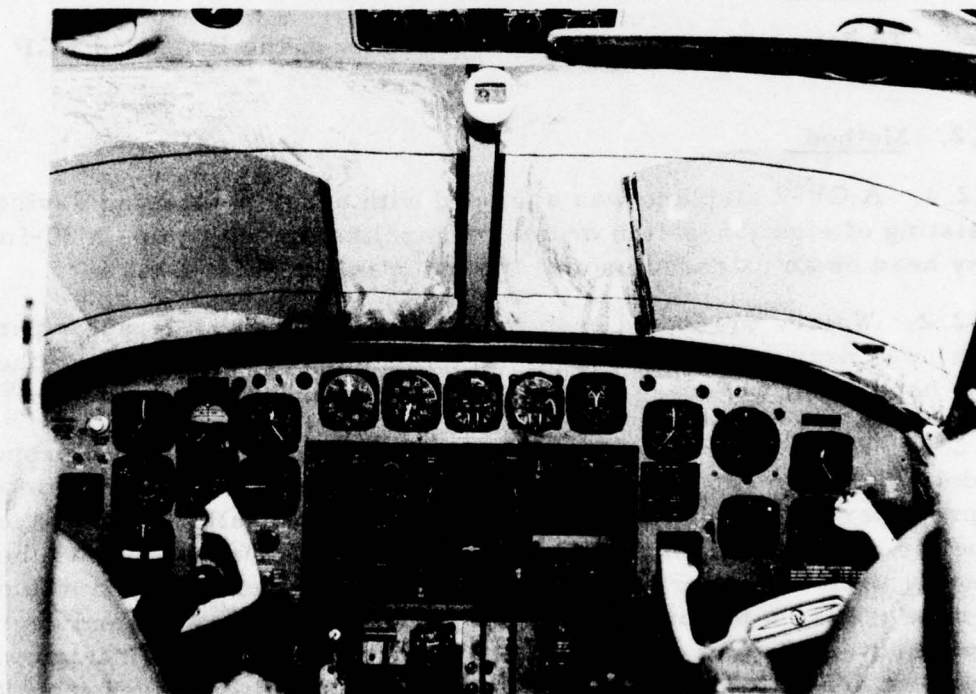
Figure 3. Black lines denote heated area of windshield and the cleared area denotes wiper coverage.

2.2.3.2.2. Heated portion of windshield did not correspond to the area cleared by the windshield wiper (figure 3).

2.2.3.2.3. The windshield wiper blades froze to the unheated portion of the windshield. Ice formation on the unheated portion of the windshield raised the wiper blades and prevented contact between the blades and windshield. Actuation of the windshield wipers while the blades were frozen to the windshield displaced the blades 90 degrees and prevented them from wiping the windshield.

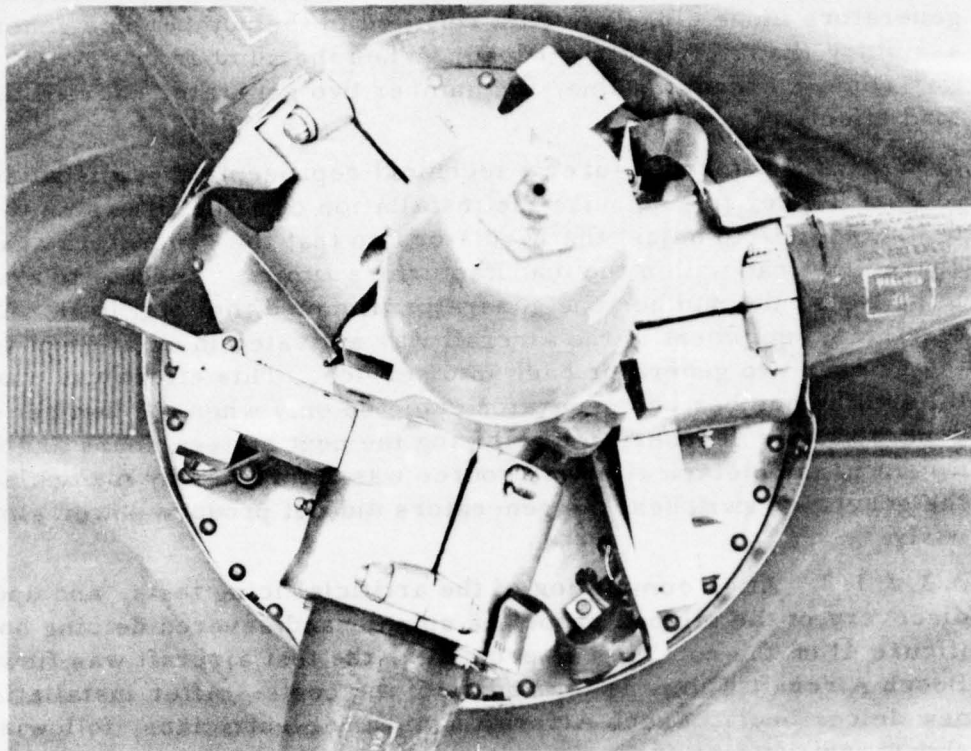
2.3.3.1.3. After completion of the artificial icing tests, and upon discovery of the slipped propeller spinner and severed deicing boots (figure 4) on the number one propeller, the test aircraft was flown to Beech Aircraft Company for repair of the boots. After installation of new deicer boots, Beech Aircraft Company electricians, following telephonic instructions from the generator manufacturers, attempted to parallel the generators. During this attempt the voltage adjusting mechanism on the number two generator voltage regulator failed. The aircraft was then flown to an airport near the generator manufacturer's plant in Waynesborough, Virginia. The voltage regulator of the number two generator was replaced, and both regulators were adjusted to parallel the generators within the manufacturer's specifications.

Figure 4. Damaged deicer boots

5. Propeller spinner slipped and severed propeller deicing boots.	The propeller boots be modified to prevent damage in the event of propeller spinner slippage.	None.

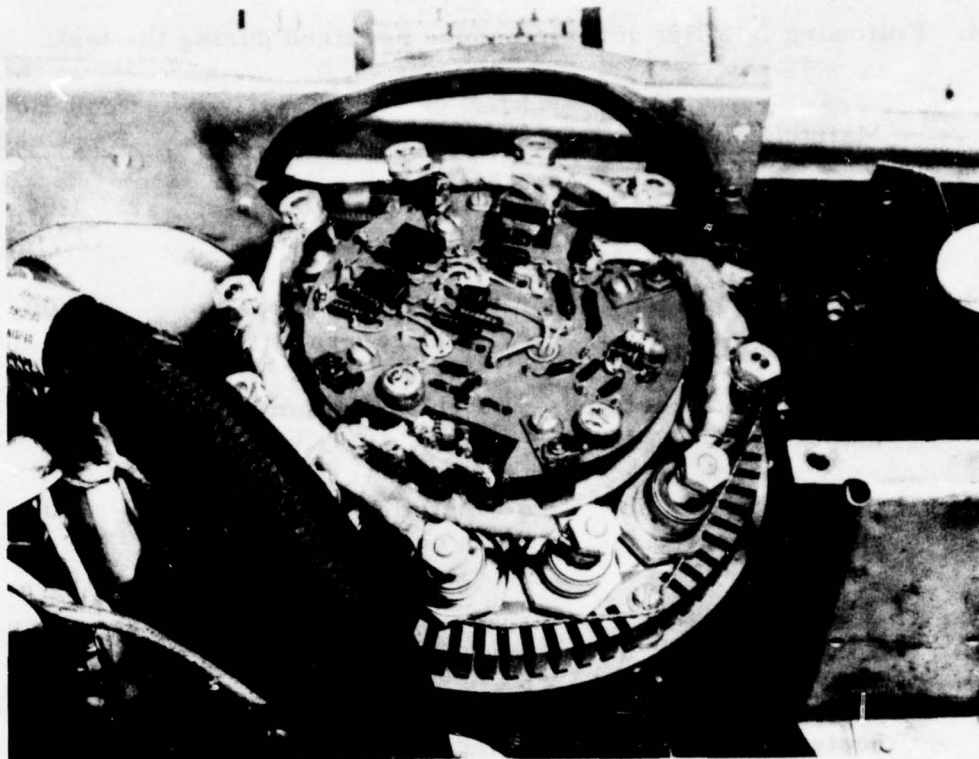
2.2.3.2. Upon the arrival of the test aircraft at Fort Rucker, the manufacturer's technical representative replaced the number one generator voltage regulator. The replaced regulator had a broken transformer mount and a broken wire in the regulator circuit (figure 5). After replacement of the voltage regulator, the number one generator still would not produce current. The new voltage regulator was later found to be defective. Both generators (and regulators) were then removed from the aircraft and returned to the manufacturer for test, repair, and calibration.

Figure 5. Voltage regulator showing transformer mount failure.
